**Subject:** Investigation into the strain on cabin crew members assisting passengers with reduced mobility  
(PRM – Passengers with Reduced Mobility)

**Responsible for project:**  
BG Verkehr (Germany)

**Country:**  
Germany

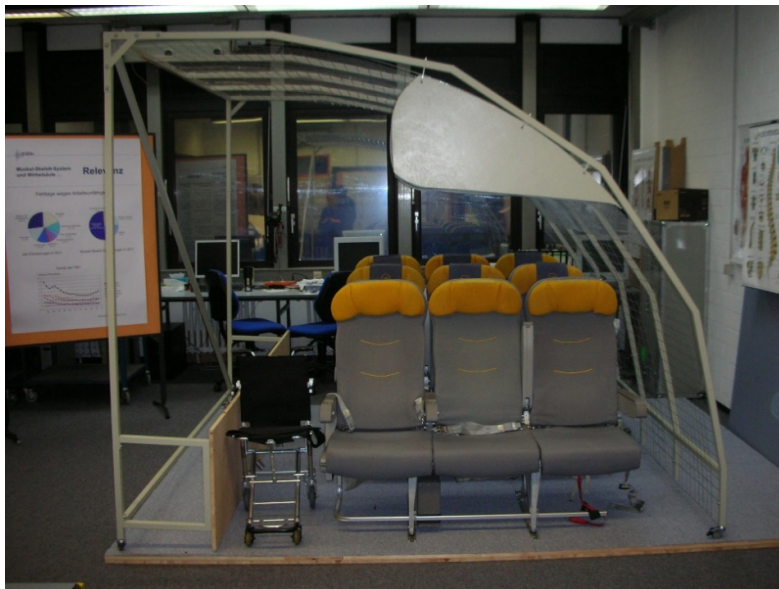
In order to establish a risk assessment adapted to the changed conditions and use this to determine suitable measures, a team of experts was put together by the occupational accident insurance institution and airlines. This was supported by scientific institutions and an aircraft manufacturer. To better visualize the processes in practice and support these with trials and tests of various aids, a mock-up of part of an Economy class cabin of an Airbus A340 including window seats was built at the IfADO.

### Mock-up at the IfADO

Together with experts, flight attendants were now able to integrate and rate the aids on the market previously analyzed and selected in structured courses of action.

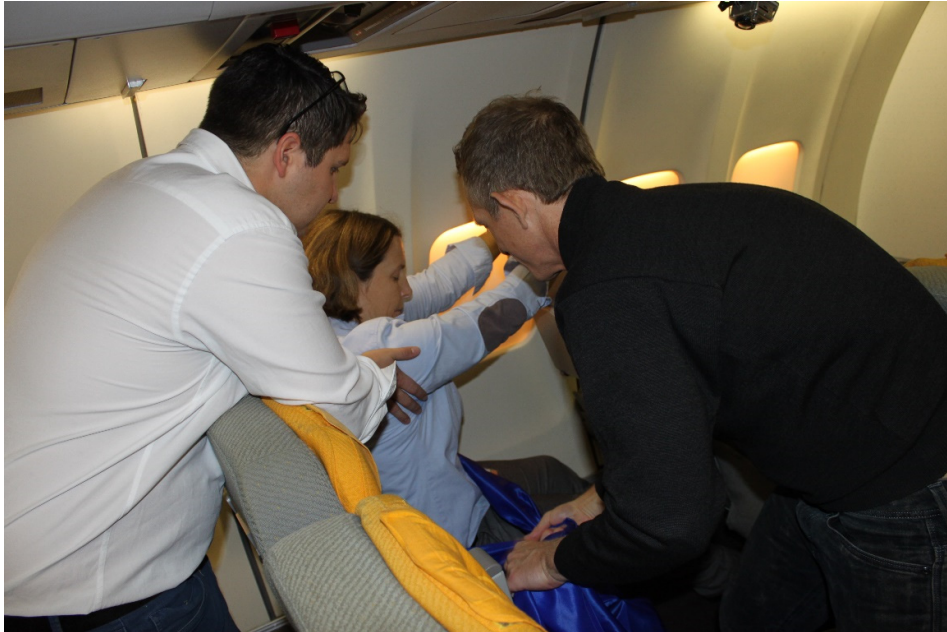
After many trials and several months, a pair of slider sheets in the form of large loops made from silicone-coated polyester fabric proved successful. This fabric has already been used as pads for repositioning bedridden patients and exhibits outstanding features. Additional test runs were conducted with flight attendants in the cabin simulator of a major airline and then evaluated.

### **Simulator training**

The extremely positive results of these usability tests gave hope this aid could soon be widely used on long-haul aircrafts. Parallel to this, a digital practical guide and flashcards were developed to familiarize the flight attendants with its use.

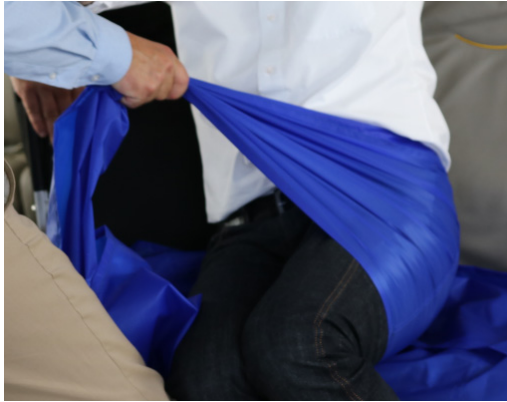
**Loops in use**  
© BG Verkehr

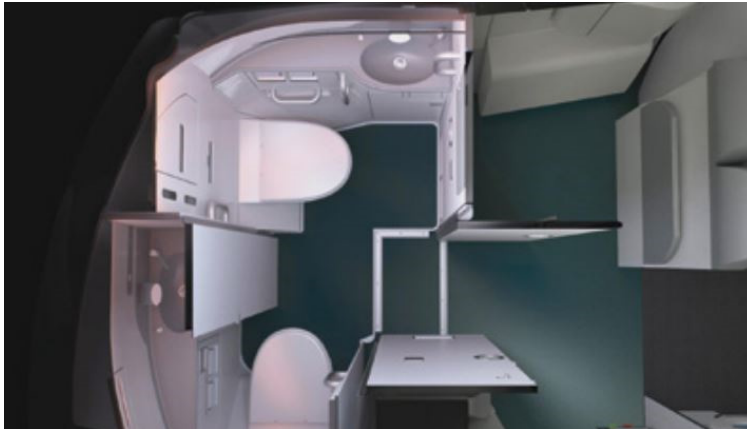
As Airbus quickly recognized that the implementation of the EU regulation only required the flight attendants to provide the PRM with assistance to the entrance of the toilet, not inside the cramped bathroom, Airbus developed new on-board toilets for the A 320 Neo, A 380 and A 350. In this new double toilet cabin, the partition between the two toilet cabins can be removed if necessary to create more room for using the on-board wheelchair. This solved the issue of being unable to transport the PRM into the confined bathroom in a wheelchair on standard aircraft types.

**Double toilet with removable partition**  
© Airbus Group
